TECHNICAL REPORT

DEVELOPMENT, TESTING AND EVALUATION

INTERNAL RESTRAINT SYSTEM

TRANSPORTING ORDNANCE IN

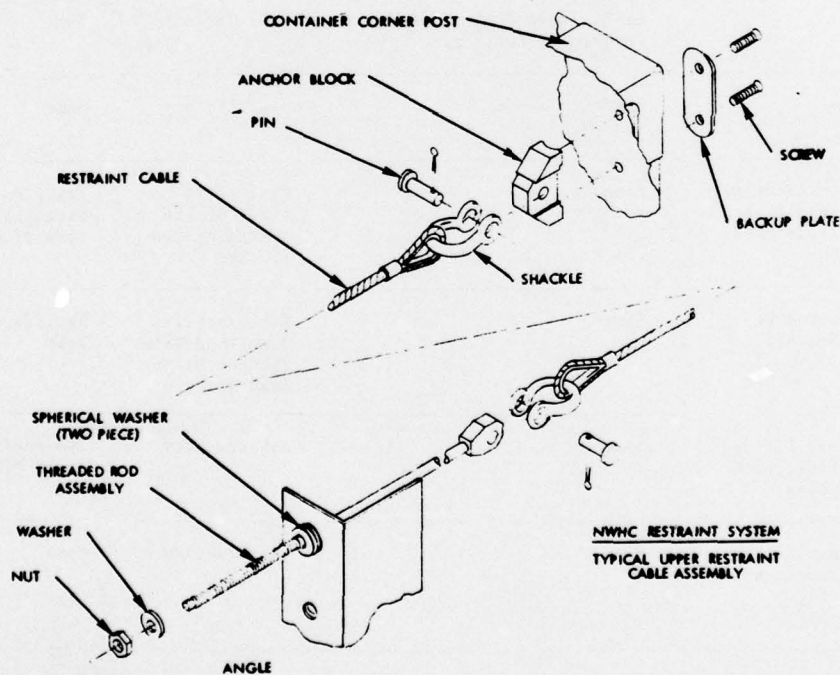
Figure 1 - Details of IRSKIT Hardware

1. Four 5/8 inch diameter steel wire rope assembly.
2. Four steel anchor blocks.
3. Four threaded steel rods 1 inch x 8 UNC x 48 inches.
4. Four back-up plates.
5. Two aluminum structural angle 8 L 2 x 85 inches.
6. Two spherical washer pairs (or swivel fittings).
7. Miscellaneous hardware.

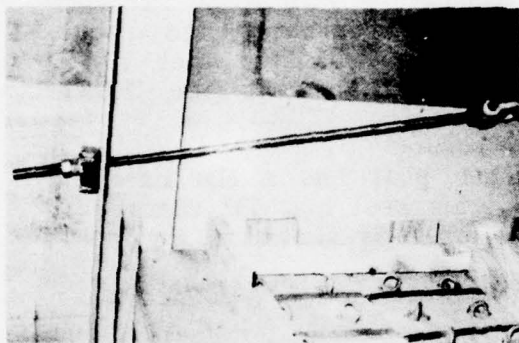
Figure 2 - Restraint Rod, Structural Angle and Swivel Fitting (Side View)

The spherical washer arrangement (or swivel fitting) provides the nut at the end of each upper threaded rod with a flat bearing surface regardless of the angle which the cable assembly may assume due to lading height. The swivel fittings were used for the COFC rail impact test series at NWHC and are shown in Figures 2 and 3. These were superseded by the spherical washers before transit from NWHC to Savanna, IL.

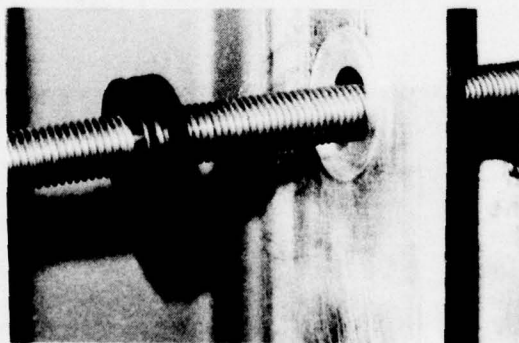
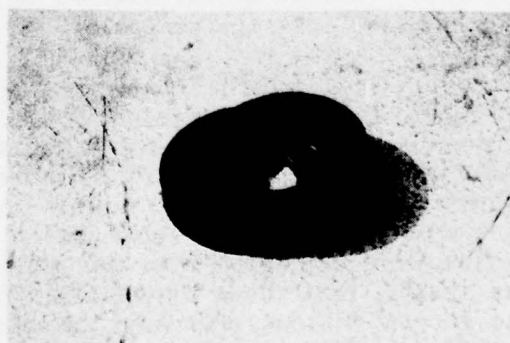
The spherical washers remained in use during all subsequent testing and evaluation. Since spherical washers are capable of compensating for a limited amount of misalignment, it was necessary to spot-face the structural angles to an additional small angle. The spherical washers and installation are shown in Figures 4 and 5.

Figure 4 - Restraint Rod, Structural Angle and Swivel Fitting With Angled Spotfacing

Figure 5 - Spherical Washer Pair As Used With Upper Restraint Rods - (All Containers)

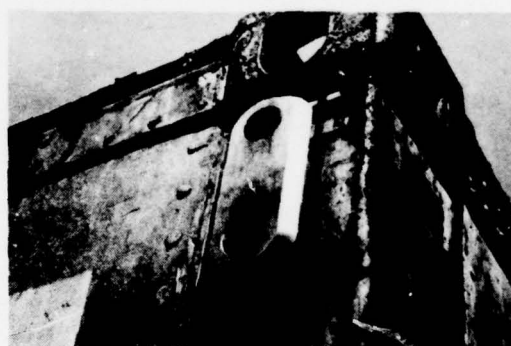
Figure 7 - Back-up Plate

One cross section of the corner post has a flat exterior. The original back-up plate designed for this post had 45° chamfer all around to eliminate sharp edges. This plate is shown in Figure 7.

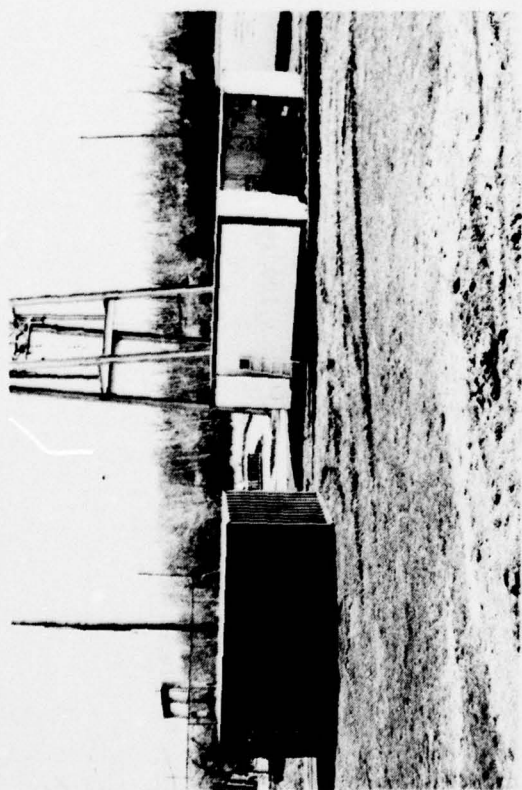
Figure 12 - Container During "Stuffing"
Prior To COFC Tests at NWHC

The containers used in this test were commercial intermodal containers as listed in Table II and manufactured to International Standards Organization (ISO) specifications. The test lading of inert ordnance corresponding to each container is also listed in Table II. Figures 12 through 15 depict the container loading area and container interiors during the stuffing operations.

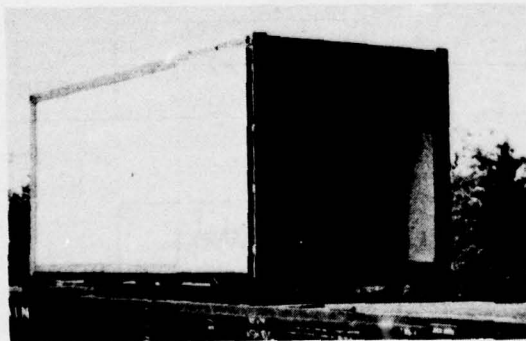
The containers with the 105MM and 155MM test lading were placed on the flatcar, as shown in the test syllabus (Table III) and Figures 16 and 17, and tested simultaneously. After completion of that series, those two containers were removed from the impact car. The container with the MK 82 Bombs (Figure 18) was then placed on the flatcar and underwent the same series of impacts. High speed photography was utilized for recording the 8 MPH ("A" END) impacts. After completion of the COFC rail impacts, the contents of all containers were removed and inspected.

Figure 16 - Container With 105MM
Ordnance During COFC
Rail Impact Tests At
NWHC

Figure 17 - Container With 155MM
Projectiles During COFC
Rail Impact Tests At
NWHC

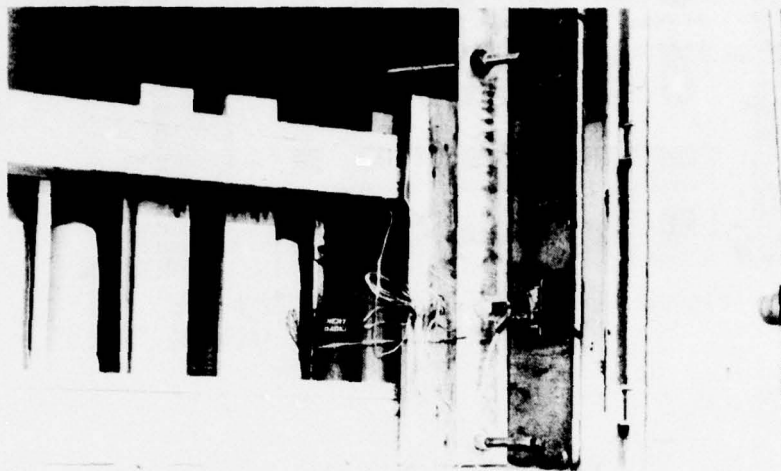
Figure 20 - Load Displacement Gauge Installed Before TOFC Rail Impact Tests

Upon arrival at AMC SAVANNA, load displacement gages were installed between each restraint system angle and container wall (Figure 20). These were installed for the purpose of measuring the longitudinal movement of the test loads within the container during the TOFC rail impacts.

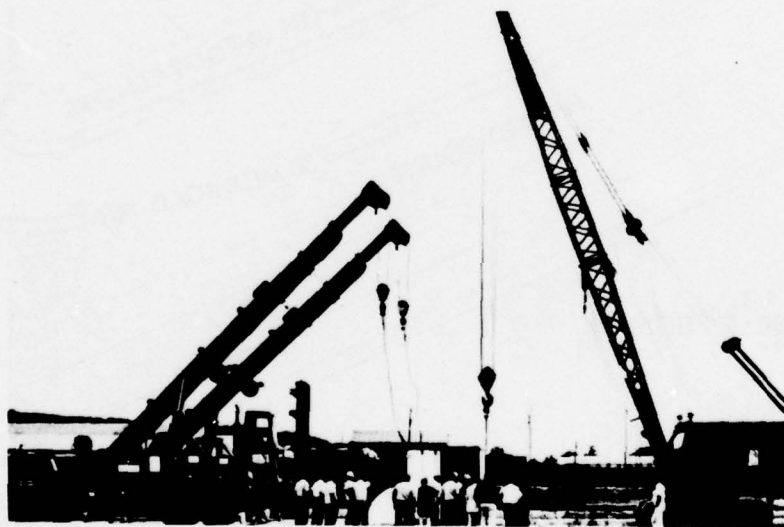
Figure 24 - 80° Tilt Test Configuration
At AMC Savanna

The 80° tilt position was maintained for 5 minutes.

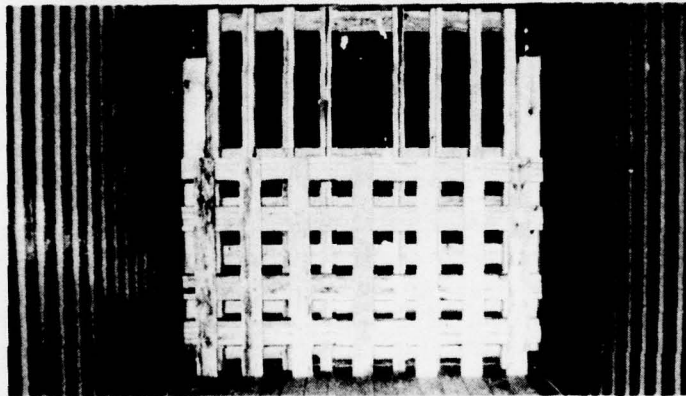
Figure 26 - Adapter Installed Between Front Bulkhead and Front Wall Panel In All-Steel Container

A duplicate test configuration, (with a redesigned forward-bulkhead section) was subsequently tested with no discernible damage to the closed end wall and corner posts. The forward bulkhead was retained, but an adapter was fabricated. This adapter was placed between the bulkhead and the container front wall and corner posts (Figure 26). The adapter was designed to conform to the container front wall contours and to distribute the force of impact over the maximum front wall panel and corner post area. The combined bulkhead assembly and adapter has approximately three times the bearing area of the original bulkhead.

The testing of this bulkhead consisted of impacts toward the closed end at 4, 6, 8 MPH and impacts toward the open end at 8 MPH which were followed by another impact toward the closed end at 8 MPH.

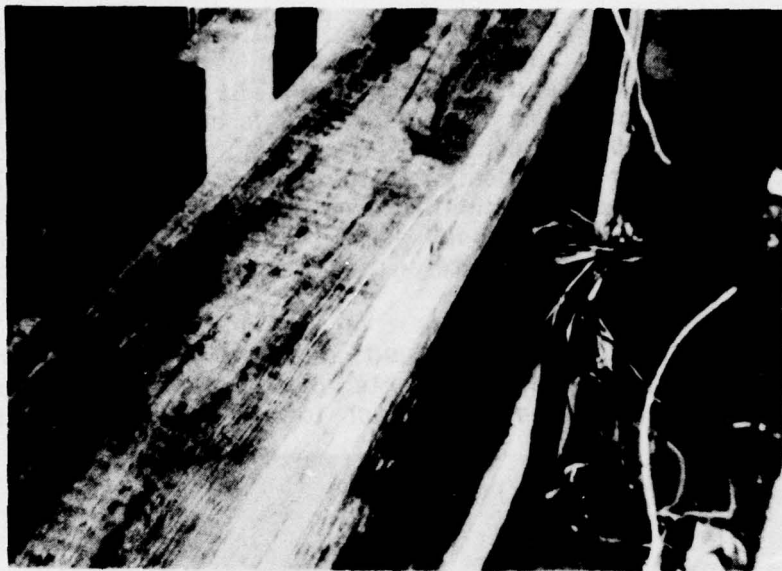
Figure 27 - Crack In Top Board Of
Rear Bulkhead

The Aluminum Exterior Container, CTI 068878, remained tight and secure throughout. A crack was noted in the top board of the rear bulkhead after the 8 MPH "A" end impact. The crack was approximately 10 inches long and located in the center area of the board (Figure 27). The crack did not propagate further throughout the subsequent testing or return transit to NWHC. After examination this bulkhead was judged to be reuseable with minimal repair.

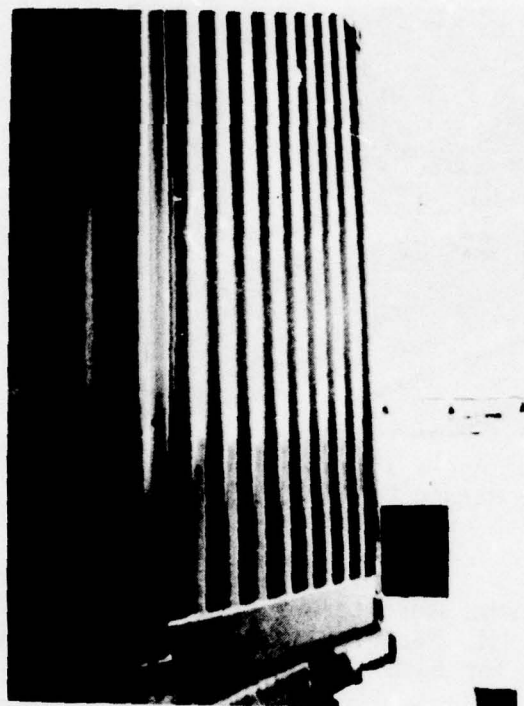
Figure 28 - Front Wall of Steel Container After Additional Impact Toward "A" End

The impacts against the "A" end (4, 6 and 8 MPH) were performed without discernible damage. The impact toward the "B" end in excess of 8 MPH produced the same type of bowing in the front wall panel as occurred in the corresponding COFC test. The maximum deflection was approximately 1/2 inch in the area corresponding to the second tier of bombs. In order to determine whether this was permanent deformation, an additional impact was made against the "A" end. The velocity was not measured but was sufficient to remove the slack in the cables and shift the load off of the front wall. The deformation which remained in the wall panel after this impact was considerably less than 1/2 inch, indicating that a major part of the initial deflection was temporary. Figure 28 was taken after this additional impact and is included for reference although little is apparent due to the dimensions involved.

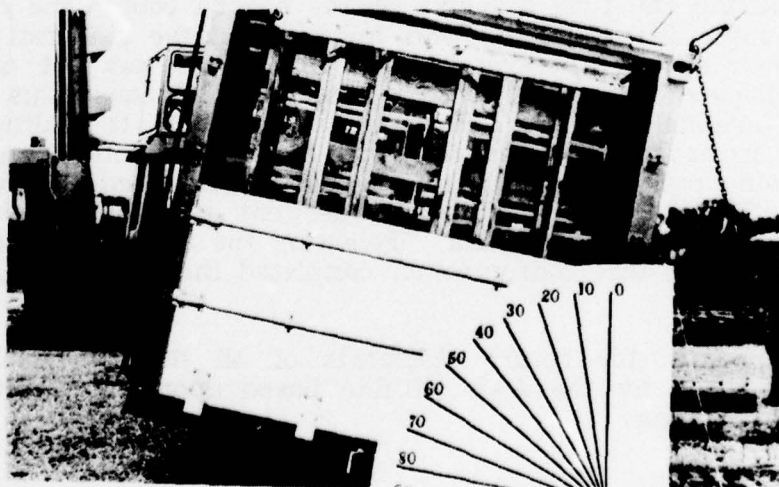
Figure 30 - FRP Container With 105MM Ordnance
Holding At 80°
26

FRP Container with 105MM Ordnance. The container completed the full tilt 0° to 80° to 0° , holding for 5 minutes at 80° (Figure 30). No change was evident. However, at the start of this tilt, there was slack evident in all cables. Although the cables had been taut when shipped from NWHC, the subsequent shipment and testing probably compressed the dunnage somewhat as well as aligned the ordnance boxes, causing the cables to slacken. The U.S. Coast Guard representative requested an additional tilt test with tensioned cables to determine the effect on sidewall deflection. The four tie rod nuts were tensioned an average of $1/2$ inch. The range was from $3/8$ to $9/16$ inches. The tilt test procedure was then repeated. The deflection measurements were in agreement with the first test. There was no evident change to the 105MM ordnance, the restraint system, or the container.

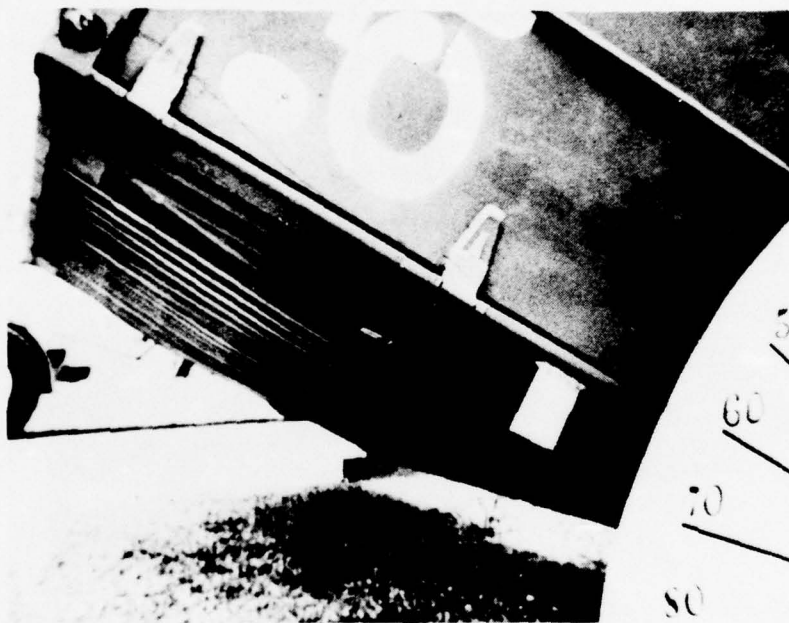
Figure 31 - Steel Container At 60° Angle During Tilt Test

All Steel Container with MK 82 Bombs. This configuration had been designated for testing without any side bracing as explained in Section II, Paragraph B. As the tilt angle was increasing from 0°, deflection was apparent from the beginning and increased to 30°. At 40°, creasing of the sidewall began due to contact with the horizontal corners of the top tier unit loads. The tilt was continued slowly to 80°, no deflection measurements were taken. The creasing and overall deformation was pronounced (Figures 31 and 32). Shortly before achieving 80°, the center dunnage spacers collapsed permitting the right side unit loads to drop onto the left. The container was returned to the upright position and no further damage such as broken welds or wall punctures was noted (Figure 33). It was agreed that the container wall had failed, not the restraint system.

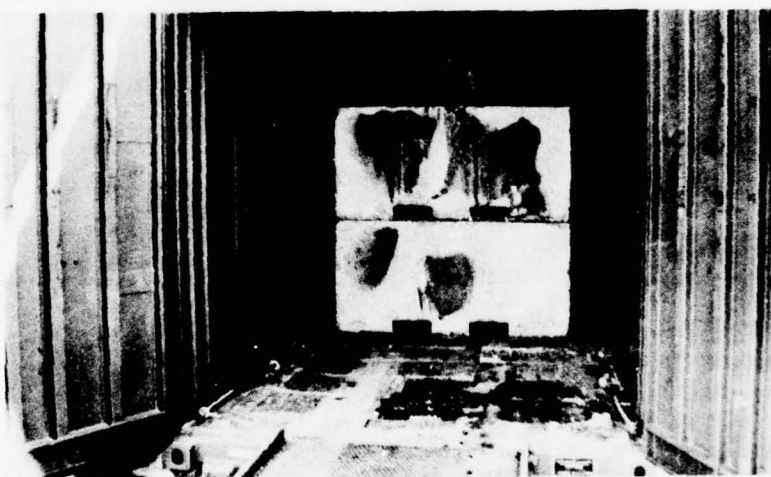
Figure 35 - All-Steel Container Partially Stuffed
With Concrete Weights (Restraint
Assemblies Visible On Floor)

In order to achieve the ANSI/ISO overload requirements, the inert ordnance was replaced by contractor furnished cast concrete weights (Figure 35).

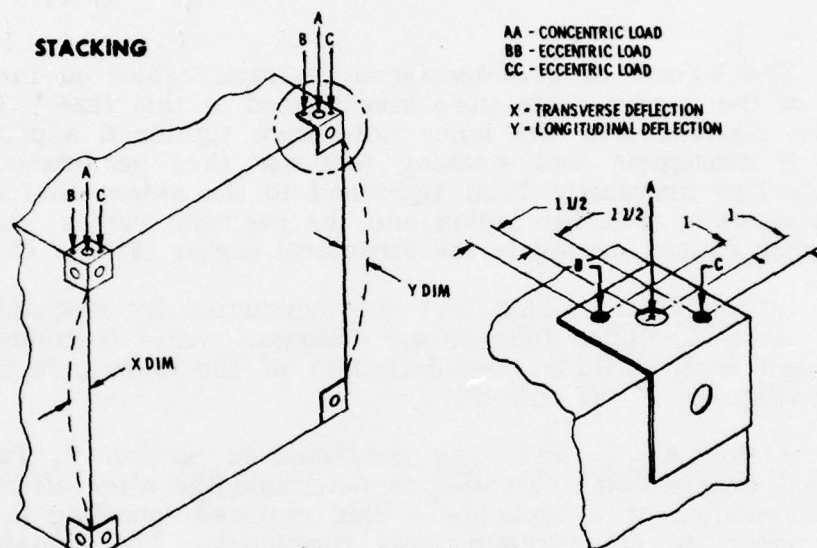
Figure 40 - Stacking Test (Schematic)

ANSI/ISO test procedures specify that the stacking strength of the container corner posts shall be determined with the applied compressive forces located both concentrically and eccentrically relative to the center of the corner fitting. This is shown schematically in Figure 40. The actual test set-ups are depicted in Figures 41 through 44.

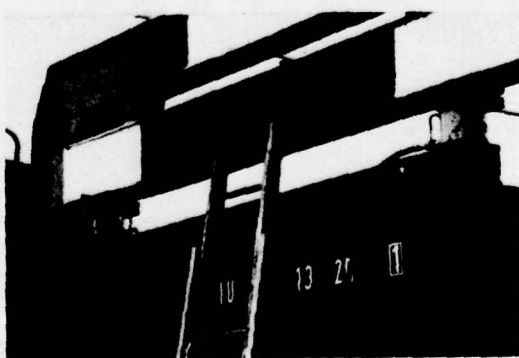
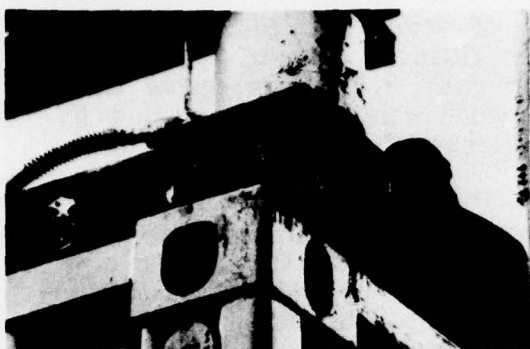
Figure 41 - Concentric Stacking Test
Both Hydraulic Cylinders
Applying Compressive Load
Through Corner Fitting/
Floor Crossmember Assembly

Figure 42 - Dial Indicators Used For
Measuring Corner Post
Deflection In Two Planes
During Stacking Tests

Figure 43 - Eccentric Stacking Test
(B-B)

Figure 44 - Eccentric Stacking Test
(C-C)

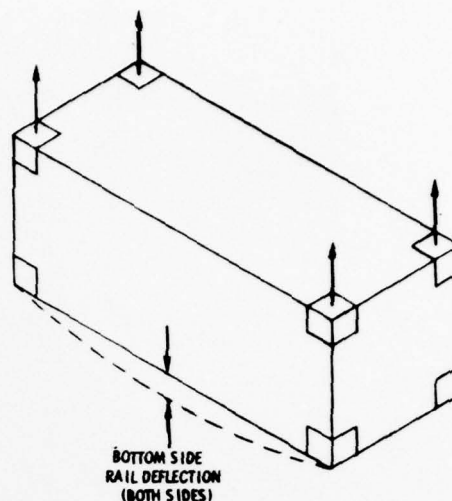
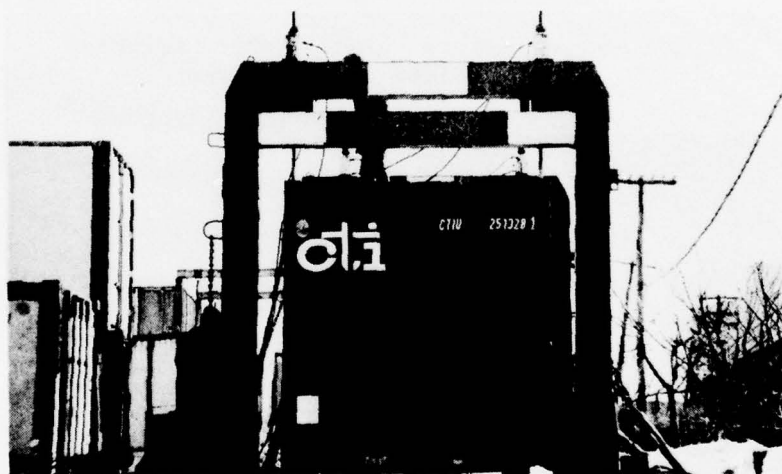
Figure 46 - Lifting Test Schematic

Figure 47 - Lifting Test - Two Hydraulic Cylinders At Each Test Frame Attached To Upper Corner Fittings

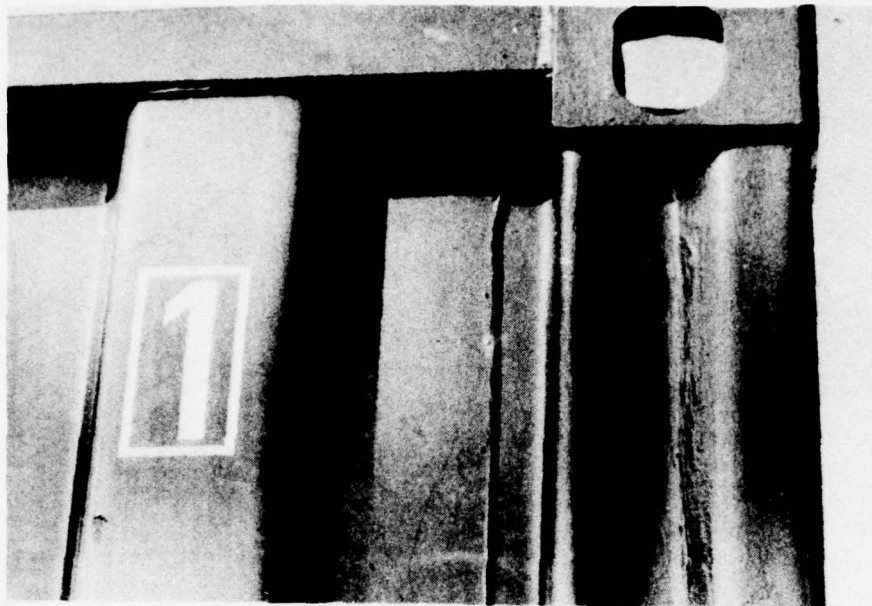
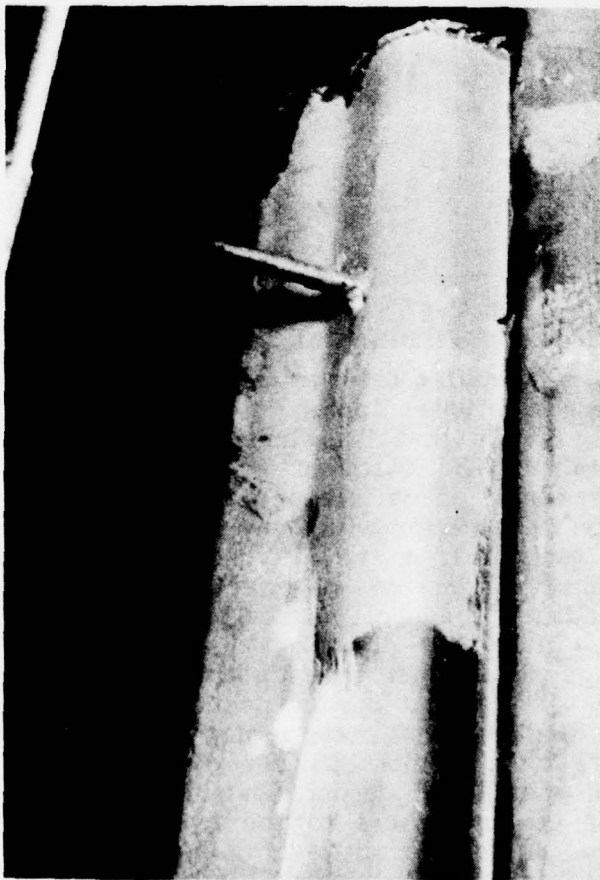
Additionally, the data suggests further investigation into the necessity or method of restoration of the front corner posts after removal of the IRSKIT attachments. Reduction of these restoration costs has a significant bearing on the life cycle cost of IRSKIT. Heretofore, charges for complete replacement of the drilled corner posts have been incurred by NWHC upon return of the containers to the lessors. It now appears that replacement corner posts offer little or no structural advantage over either the as-modified or the plug welded posts.

Figure 48 - Exterior: Right Corner Post-Plug
Welded and Contoured

Figure 49 - Interior: Right Corner
Post-Plug Welded and
Contoured

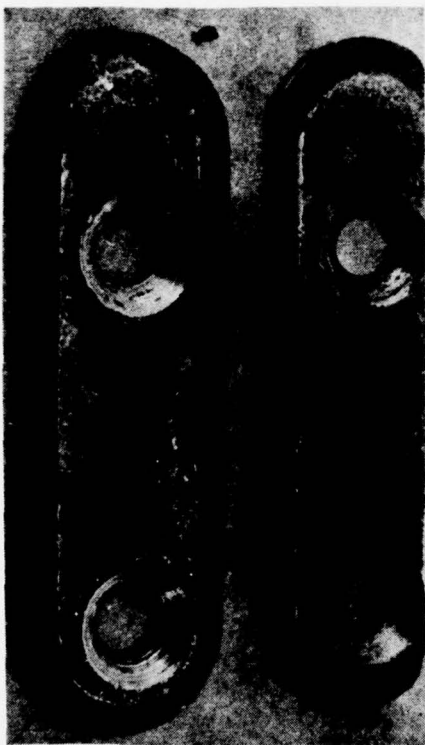
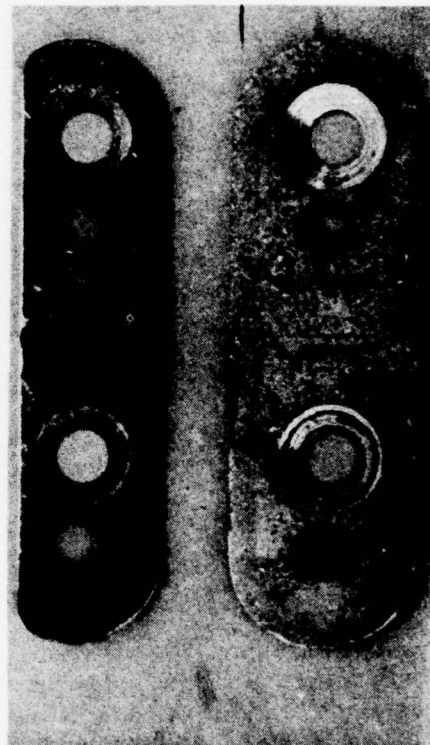
Figure 51 - Backside View Of Modified Back-up Plate (Right) versus As-Supplied Plate (Left)

Figure 52 - Frontside View Of Modified Back-up Plate (Left) versus As-Supplied Plate (Right)

Figure 53 - Modified Back-Up Plate
As Installed In One
Type of Corner Post

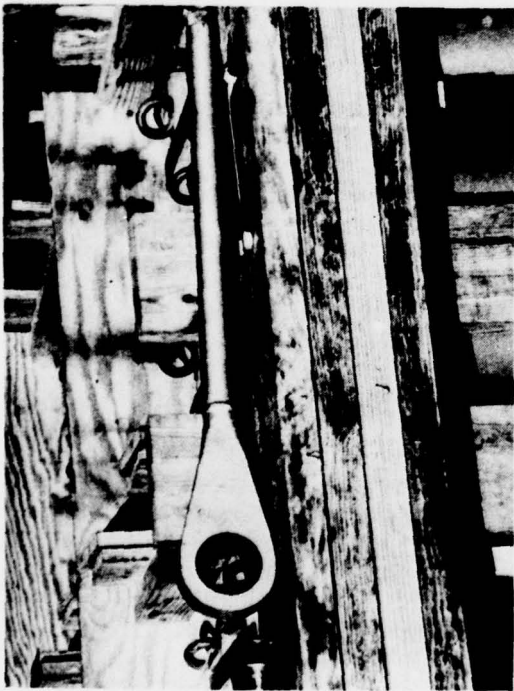
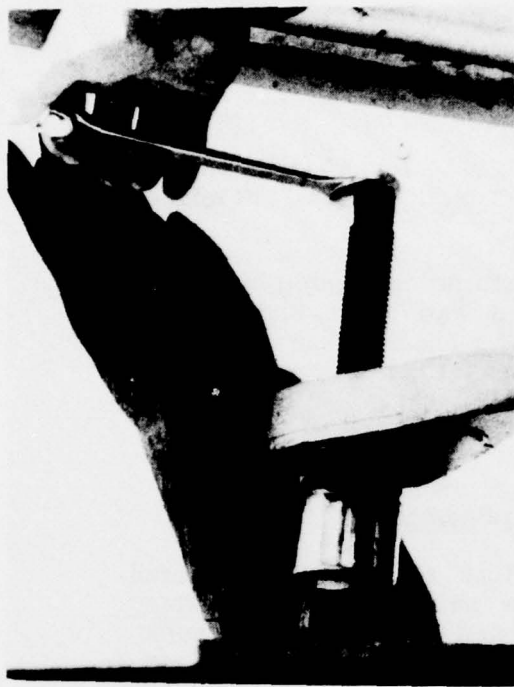
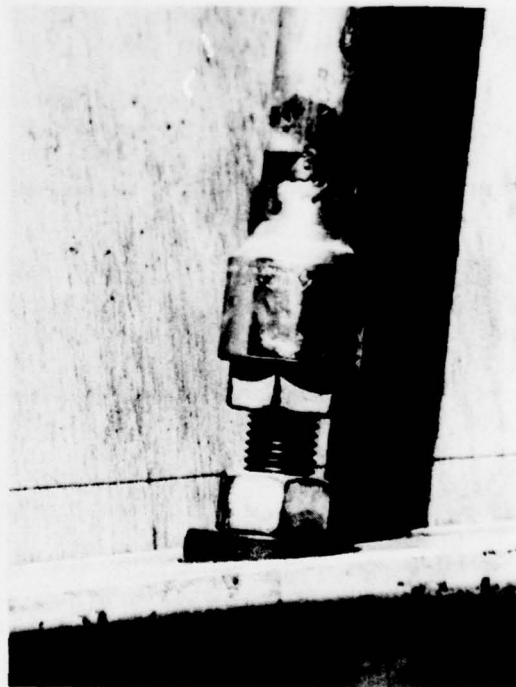
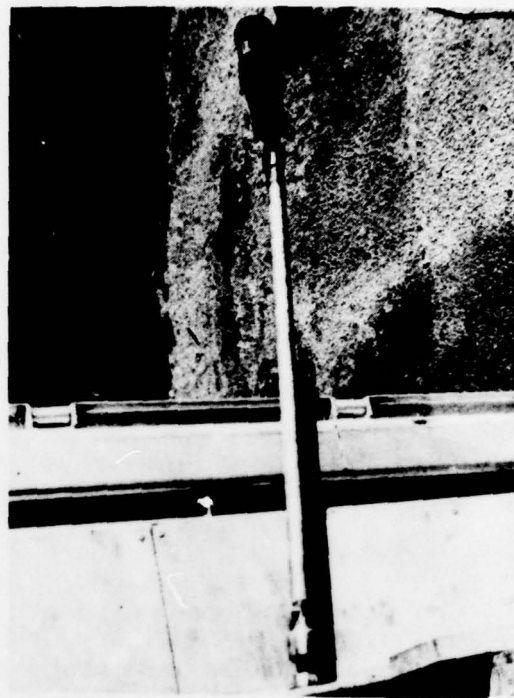
Figure 55 - Reversible Ratchet Box Wrench and 1-1/2" Socket Wrench Adapter Shown Separated

Figure 56 - Reversible Ratchet Box Wrench and 1-1/2" Socket Shown Tightening The Rod Jam Nut (Open End Wrench On Wrench Flat To Prevent The Rod Turning)

Figure 57 - Close Up View of 1-1/2" Socket and Portion Of The Extension (Also Shown Is The Spherical Washer Recessed Into Angles Spotface)

Figure 58 - 1-1/2" Socket, 36" Extension and Impact Wrench During Jam Nut Installation On 155MM Projectile Load

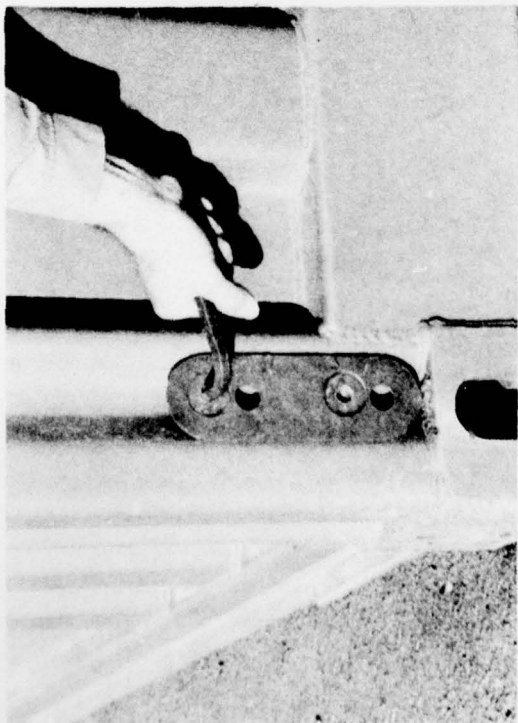
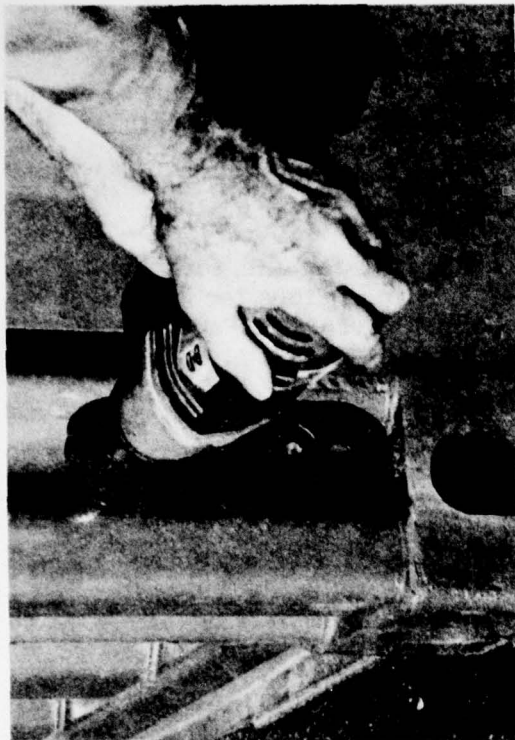
Figure 59 - Hex Head Key Used To Start
Cap Screw Installation

Figure 60 - Impact Wrench With Hex Head Key Bit
Used For Final Installation
Of Cap Screws
